# Management of the complications of penile prosthesis implantation

Alessandro Natali

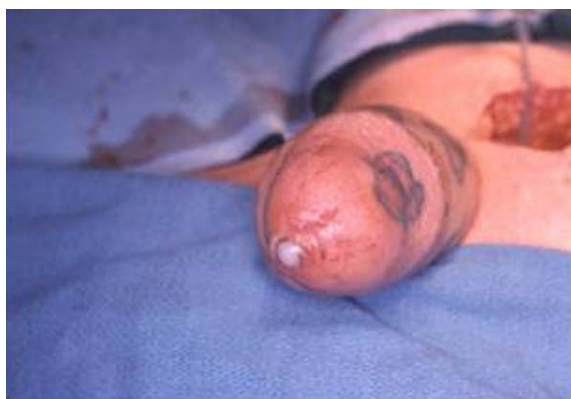
**Fig. 1** Cylinder erosion at the level of the glans (semirigid prosthesis).

Again erosion can occur in both semirigid and inflatable (two- and three-component) prostheses [2,20]. This is the most common complication and usually occurs around 6 months after implantation and in spinal cord injured (SCI) men with a penile prosthesis. Extrusion without infection in SCI patients is mainly due to the decreased blood supply and to disorders affecting peripheral sensitivity [21]. Every prosthesis component can produce an erosion: the cylinders at the level of the glans (Figs. 1 & 2), the pump can erode the scrotal skin (Fig. 3), and the tubes can erode the skin if placed too superficially. The distal erosion of a cylinder at the glans level is frequently due to the use of an oversized cylinder, and the precursor to erosion is protrusion (Fig. 4). Again, in these cases, it is necessary to remove the entire prosthetic device and to replace the implant in the same sitting.

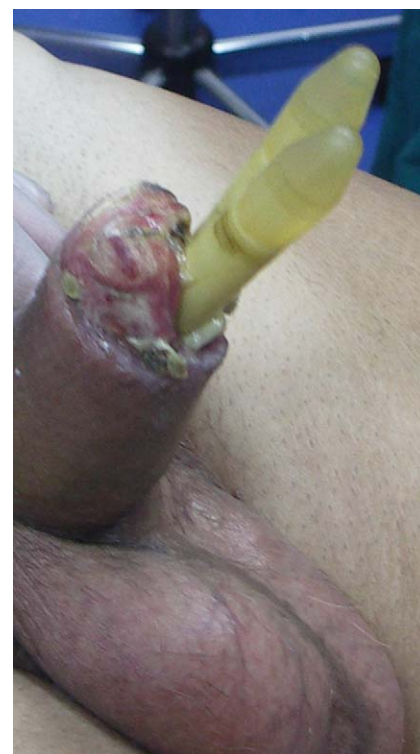
**Fig. 2** Cylinder erosion at the level of the glans (inflatable prosthesis).

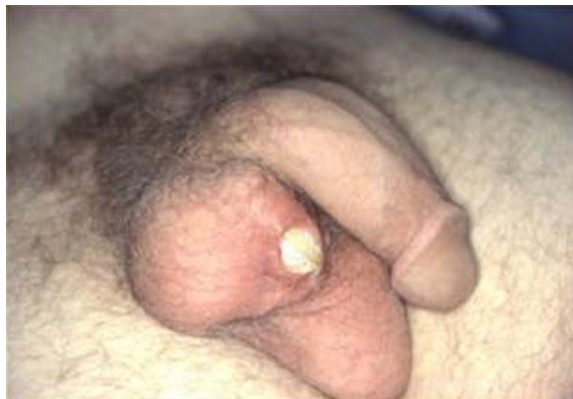
**Fig. 3** Pump erosion to the scrotal skin.

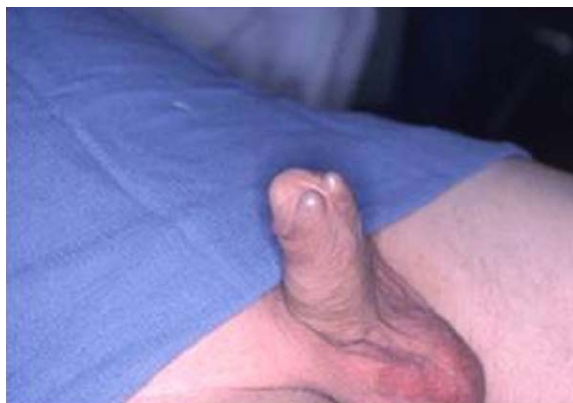
**Fig. 4** Distal protrusion of oversized cylinders (inflatable prosthesis).

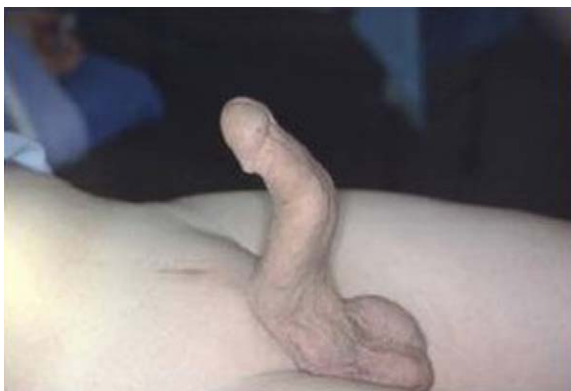
**Fig. 5** "S-Shaped" deformity of the penis.

The "S-shaped" deformity of the penis (Fig. 5) is a complication that frequently occurs after a

penile implant if complete distal dilation of the corpora cavernosa was not performed and/or cylinders that are too short have been inserted [22]. In such cases, the device has to

be removed, the distal part of the corpora cavernosa has to be inflated and the replacement prosthesis must have longer cylinders.

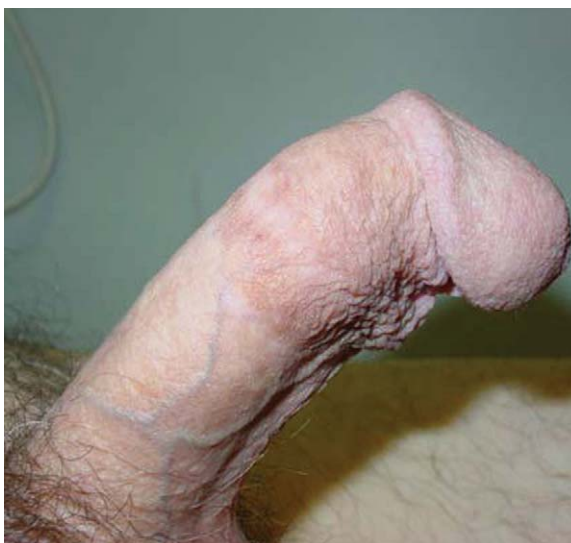
**Fig. 6** "Concorde syndrome" floppy glans.

This is a particular condition that occurs after a penile implant if an undersized cylinder has been used. It results in a “floppy and hypermobile glans” (Fig. 6), which resembles the very distinctive nose of the supersonic transport (SST) aircraft, Concorde (Fig. 7). This condition can produce some problems in sexual intercourse. Cylinder removal is not necessary and the best treatment involves the partial dissection of the glans from the underlying tissue using a subcoronal incision, followed by fixation of the glans, using non-absorbable sutures, to the tips of the corpora cavernosa.
